**NEDC et al. v USACE et al:** (Case No.: 3:18-cv-00437-HZ)

# **Assessment of risks to human life and safety from proposed modifications to operations**

**Prepared for: Judge Marco A. Hernandez**

**Prepared by: Desiree Tullos, PhD PE (OR)**

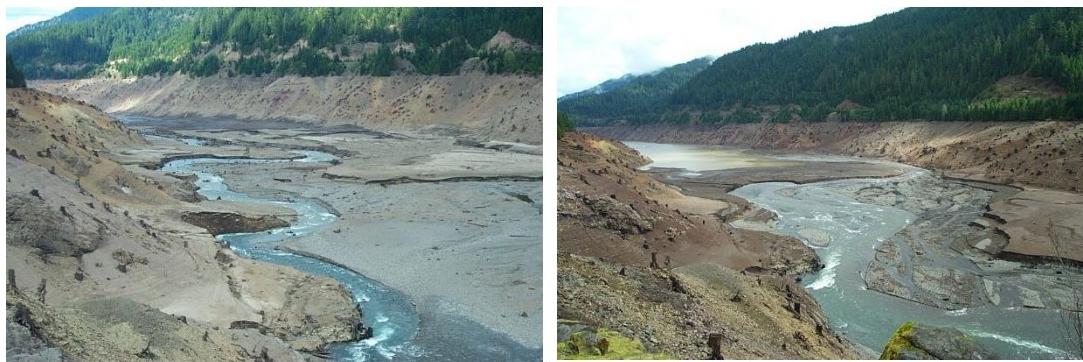
Supporting the assessment of low landslide risk, a prior drawdown of the reservoir that occurred in 2002 for construction of the temperature control tower (Figure 6) did not appear to appreciably affect the landslide deposits. During that drawdown event, some vertical and

lateral erosion did occur, resulting in elevated suspended sediment downstream. In addition, the drawdown also exposed and eroded former landslide deposits that had been submerged under the reservoir, producing elevated suspended sediment concentrations (G. Grant, personal communication). However, while downstream habitats were impacted by the intrusion of fine sediments into spawning gravels (Grant et al 2015), areas of substantial deposition downstream were not documented. As a result, this measure is rated as *no appreciable risk* for elevated sediment instability.

**Figure 6. Vertical and lateral erosion at Cougar reservoir during the 2002 drawdown** (Source G. Grant, USFS).
